552-554 BROADWAY  
New York, New York

# Preservation Tech Notes

## HISTORIC GLASS NUMBER 2

### Repair and Rehabilitation of Historic Sidewalk Vault Lights

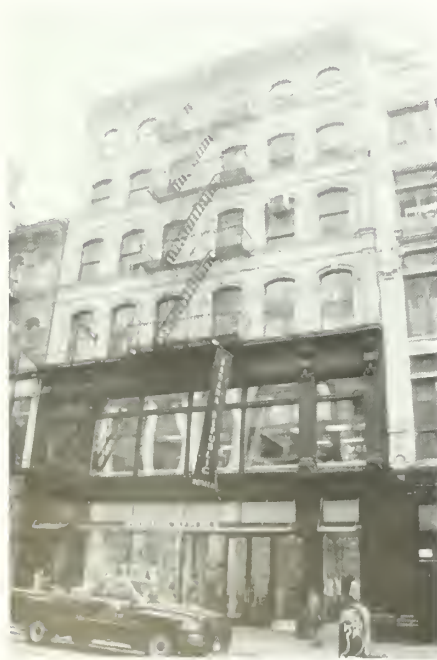
Figure 1. A cast-iron storefront was added to 552-554 Broadway in 1897. The storefront included a fifty-four foot long assembly of cast-iron vault lights set in the sidewalk. Glass lenses in the panels allowed light to enter the basement area, increasing rentable space for the building owner.

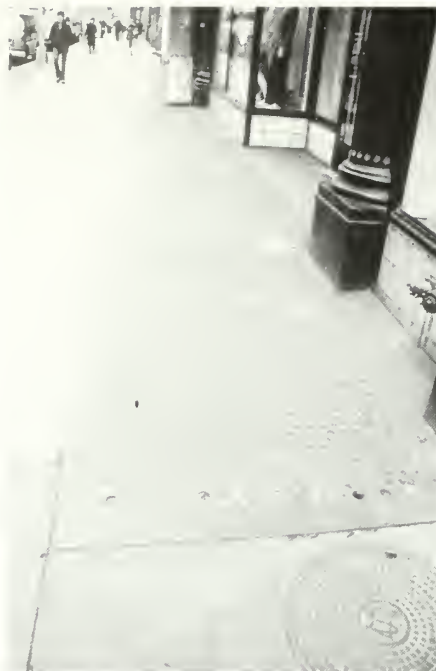
Figure 2. At the outset of the restoration project, the original cast-iron and glass vault lights in front of the building's storefront were in poor condition.

At the outset of the project, the vault lights at 552-554 Broadway were in poor condition (*see figure 3*). As with many old vault light installations, broken glass lenses and deteriorated seals allowed considerable water infiltration through the individual panels and the surrounding framework. A majority of the glass lenses were either cracked, missing or replaced with a variety of materials including wood, concrete and asphalt (*see figure 4*). Of the twenty-one cast-iron panels, six sections had areas which were cracked or missing altogether. Two original vault light panels had been replaced with steel diamond-plate hatchway doors to the basement and a variety of materials had been applied over the remaining panels in repeated attempts to prevent further leaks. Worn and lacking a protective coating, the cast-iron panels

were exposed to the elements. Displaced panels and uneven asphalt and concrete patches presented trip hazards at sidewalk level.

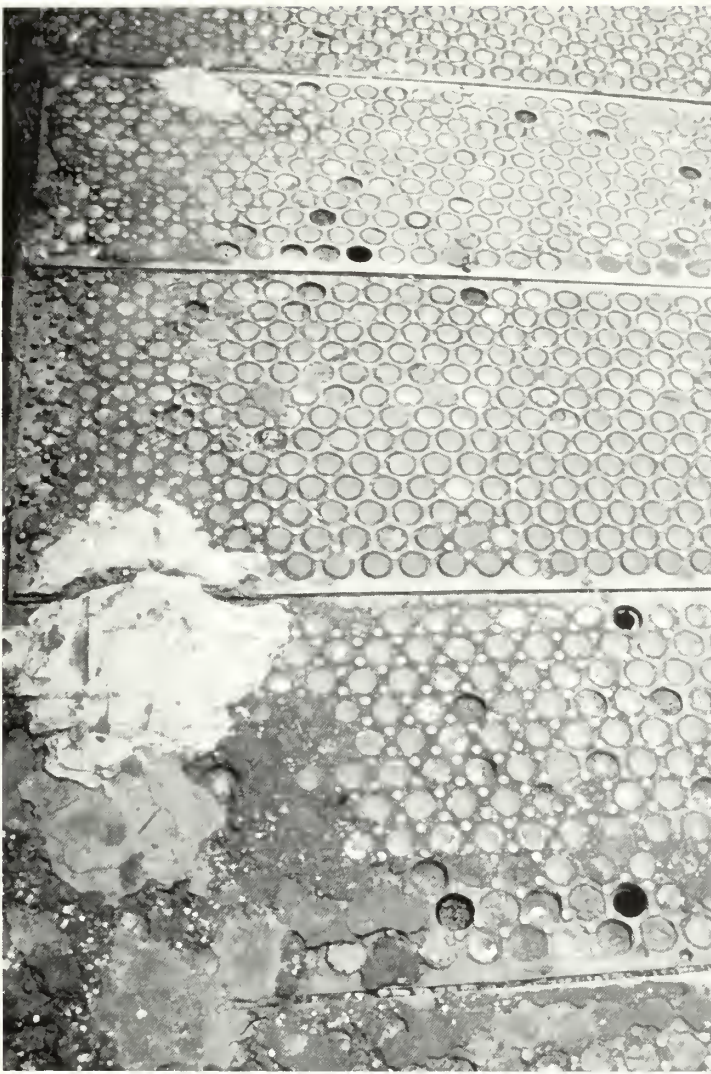
Figure 3. The individual cast-iron panels were displaced and coated in some areas with asphalt and concrete. A number of glass lenses were missing, allowing water to enter the basement of the building.

To facilitate treatment and allow the sidewalks to remain unobstructed, the panels were removed and temporary steel plates were installed over the vaults. In the cast-iron contractor's workshop, the surviving deteriorated glass lenses were removed, the cast iron stripped, cleaned and repainted, and new lenses set into the openings. Replacement lenses were cast by a specialty glass manufacturer, Blenko Glass Company. The company had created glass molds for a vault light restoration several years prior and were now a regular supplier of various sized lenses for similar projects. A cast-iron foundry was contracted to fabricate two new panels to match the missing historic panels. Both new and repaired panels were delivered to the building site where the cast-iron specialist reinstalled them.

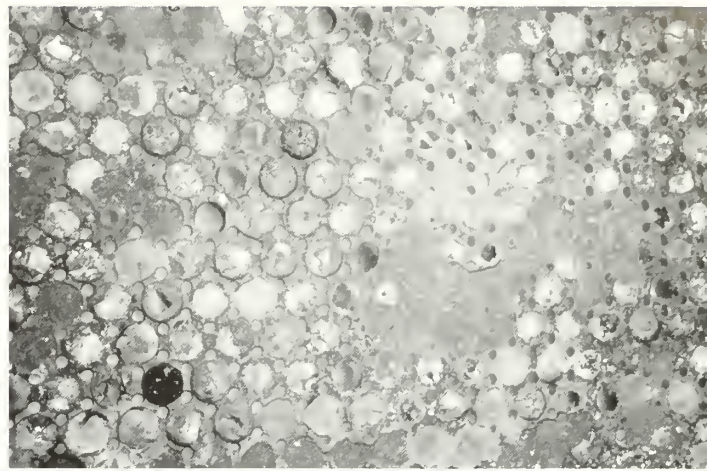
Figure 4. A detailed view of one of the panels illustrates the typical conditions prior to work. Although the original cast-iron knobs were still visible through the asphalt and concrete, many of the round openings were covered over or infilled. Nearly all of the remaining glass lenses were cracked.

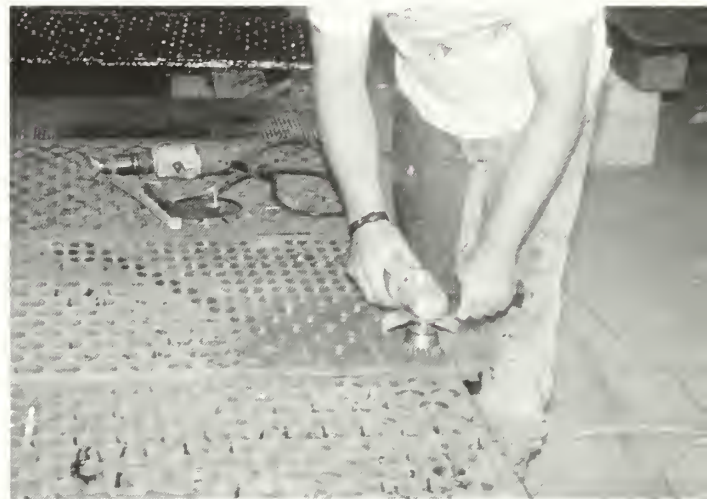
Figure 5. Workers removed any remaining corrosion, grout and other contaminants with hand chisels and power-operated wire brushes.

cleared off the paint, chewing gum, tar, asphalt, concrete, corrosion, grout and other grime that accumulates on a New York City sidewalk over the course of a century, without pitting or otherwise damaging the cast-iron. Then, workers cleaned each of the panels with small chisels and drills fitted with wire brush attachments to remove any material missed during sandblasting (see figure 5).

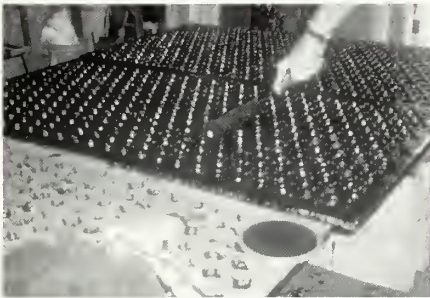
Figure 7. Cleaned and repaired panels were painted with two coats of oil-based metal primer and three alkyd gloss enamel top coats.

When repairs to the cast-iron were completed, two coats of primer were applied, followed by three coats of gloss black paint to match the existing paint color (see figure 7). The contractor used a Benjamin Moore system including an “ironclad” oil-based metal primer and alkyd gloss enamel (Impervo) top coat that offered high abrasion resistance. A rust conversion

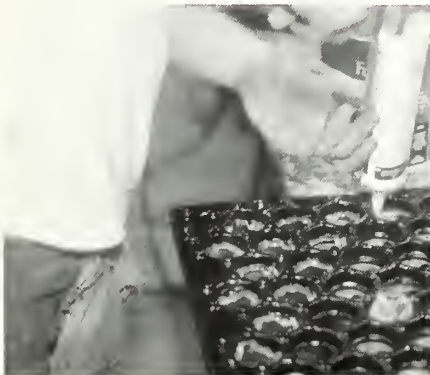
Figure 8. Before the glass lenses were set, a ring of silicone was placed along each flange on the lower edge of the opening. The silicone kept the lens centered in the cavity while a waterproof grout was used as the main sealer.

After ensuring that the panels were dry and free of oils, dirt, dust and other contaminants, a bead of silicone was applied at the bottom of each of the round openings (*see figure 8*). This preliminary seal would keep the glass centered during the grout application. Replacement lenses were obtained from a specialty glass manufacturer that has supplied new lenses for a number of vault light rehabilitation projects. The glass lenses were set into place and a two-part epoxy grout was used to seal them in the panel and waterproof the joint (*see figure 9*). The gray, chemically-resistant material was the same used for grouting floor brick, quarry tile pavers and ceramic mosaics. Workers mixed the compound, placed it in a caulk gun and squeezed it into the areas adjacent to the lenses. Before it hardened, excess grout was removed using a dampened sponge (*see figure 10*). After twenty-four hours, the grout cured sufficiently to complete the reglazing process. The panels were turned over and workers used a razor blade to cut away excess silicone that had dripped out of the space between the lens and the cast-iron along the underside of the panel. Then, the panels were shipped back to New York City.

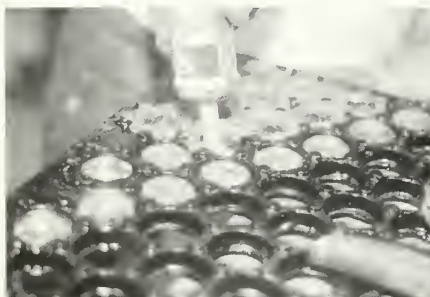
Figure 9. A caulk gun helped workers apply the waterproof epoxy grout around the lenses.

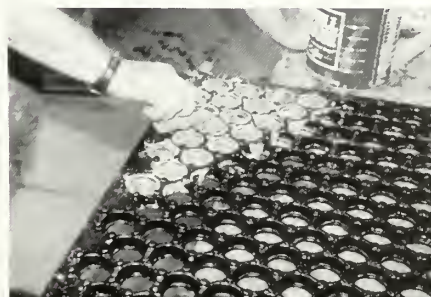
Figure 10. The grout remained water-soluble until it hardened, enabling workers to remove excess material and smooth the joint between the lens and cast-iron with a sponge.

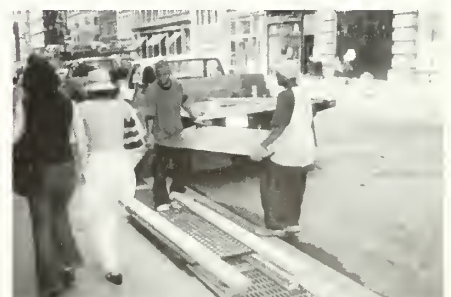
Figure 11. Just prior to installation, each panel was lifted by hand from the back of a truck and stacked on the sidewalk.

Following fabrication, the new panels were shipped to the contractor who set the new glass lenses and transported them to New York City for installation alongside the repaired panels (*see figure 11*).

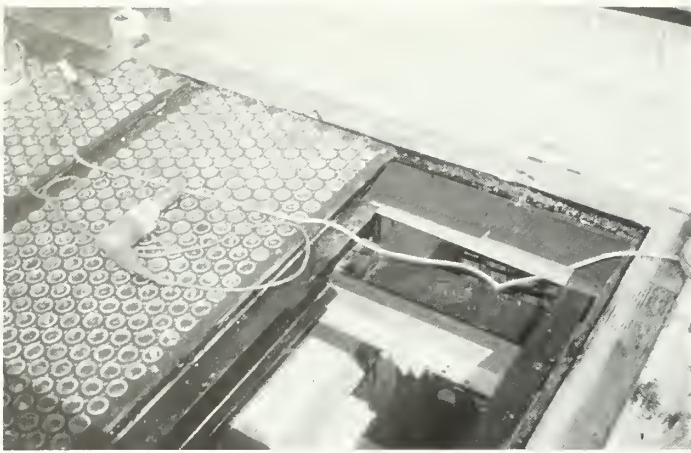
Figure 12. During the installation, each panel was set onto the supporting T-beams that span the vault. A steel supporting girder, running perpendicular to the beams, is visible within the vault opening.

spaced beneath each joint between adjacent panels (see figure 12). Additionally, newly cast frame sections were bolted together and installed beneath the sidewalk surface. As part of the current restoration, the contractor examined the substructure at 552-554 Broadway and determined that the previously rebuilt assembly did not require additional strengthening or modification.

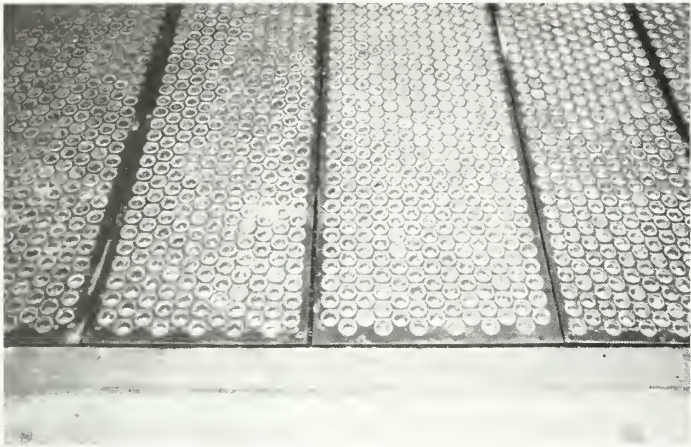
Figure 13. The restored and reinstalled panels prior to repainting the saddles.

To reinstall the panels, a bead of flexible polyurethane caulk was applied around the perimeter of the support frame. The panels were positioned on top of the sealant, in the same order they were set before removal, ensuring that the bolt holes would align (see figure 13). Four stainless steel flat-headed machine screws secured each panel to its frame-work. A flexible foam backer rod was inserted into the seam around each panel filling much of the gap. The

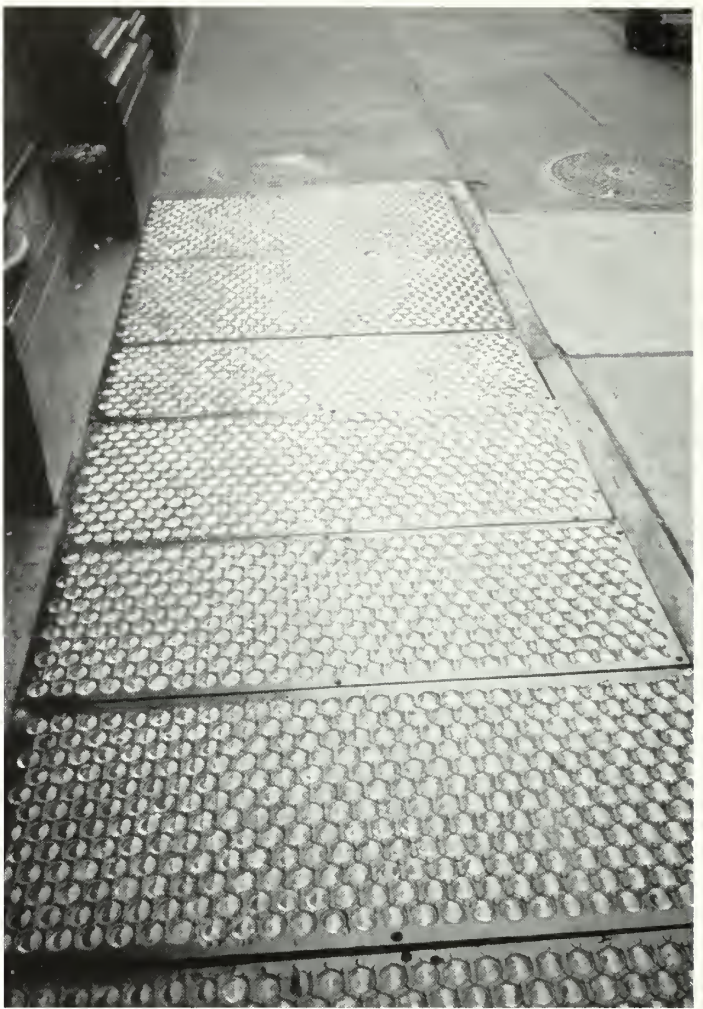
Figure 14. The restored panels after work was completed.

The project at 552-554 Broadway suggested another, more appropriate alternative: the sensitive repair and replication of the historic vault lights (see figure 14). The result was the
